Preservation Education at the Cape Blanco Lighthouse

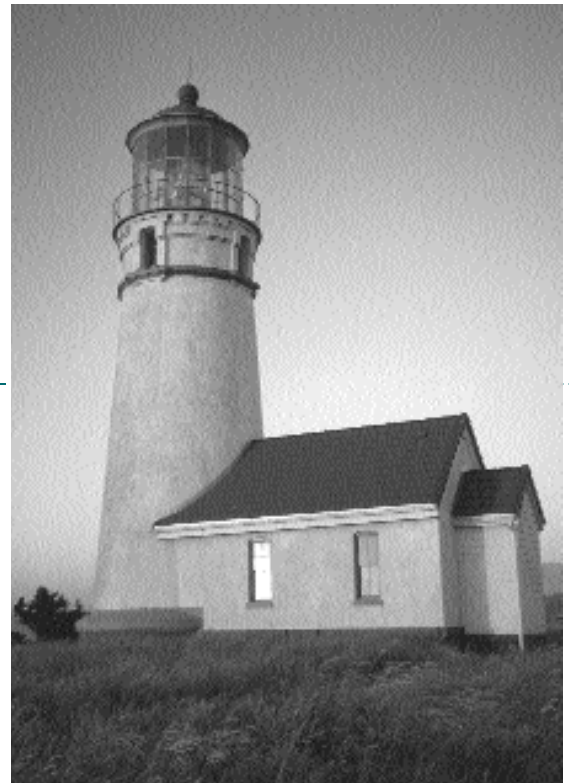
*Cape Blanco
Lighthouse (1870)
with altered work-
room roof and
enclosed entry
vestibule.*

As with any structure of its age, we were surprised by some of its modifications and accretions. For example, there used to be a decorative king post element in the gable over the entry appropriate to its 1870 construction. We found the king post's tie-beam recycled as a rafter in the work-room roof, complete with mortise and chamfered edges.

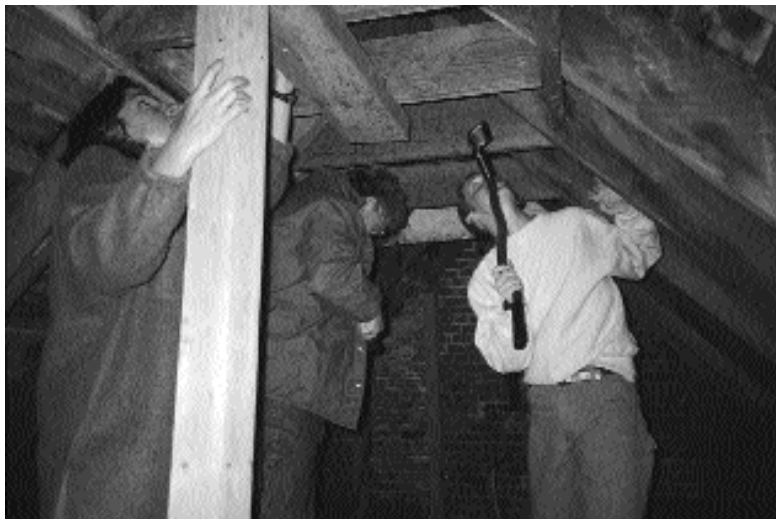
Rebecca Gershow, Art Corliss, and Justin Gray inspect the modifications made to the workroom roof structure.

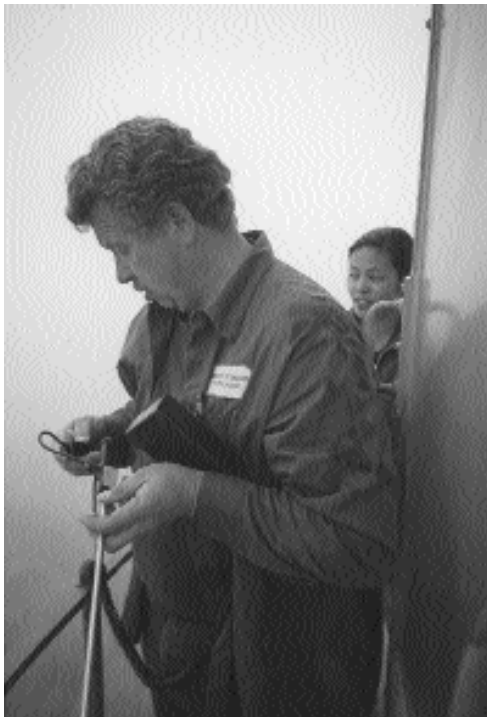
Art Corliss and Marilou Aquino preparing to use the borescope on an air intake vent.

break up the structure into a series of features (e.g., air intake vents at the watch room level), so that all the groups worked within the same parameters and definitions. In addition to the standard tools such as flashlights, clipboards, and our eyes, we used a borescope and a velocimeter to evaluate the structure. The borescope allowed us to peer through cracks to look at such features as the arched structural members within the canopy. The velocimeter showed us the

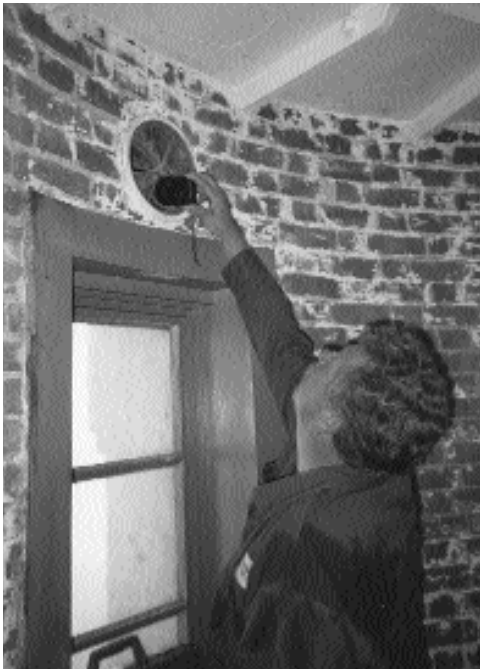
Art Corliss using a velocimeter to measure the draft through an air intake vent.
